Biosecurity Monitoring Group

Pilot Videoscopic Survey of Imported Used Vehicles and Machinery

April – June 2005

BMG 05-06/01

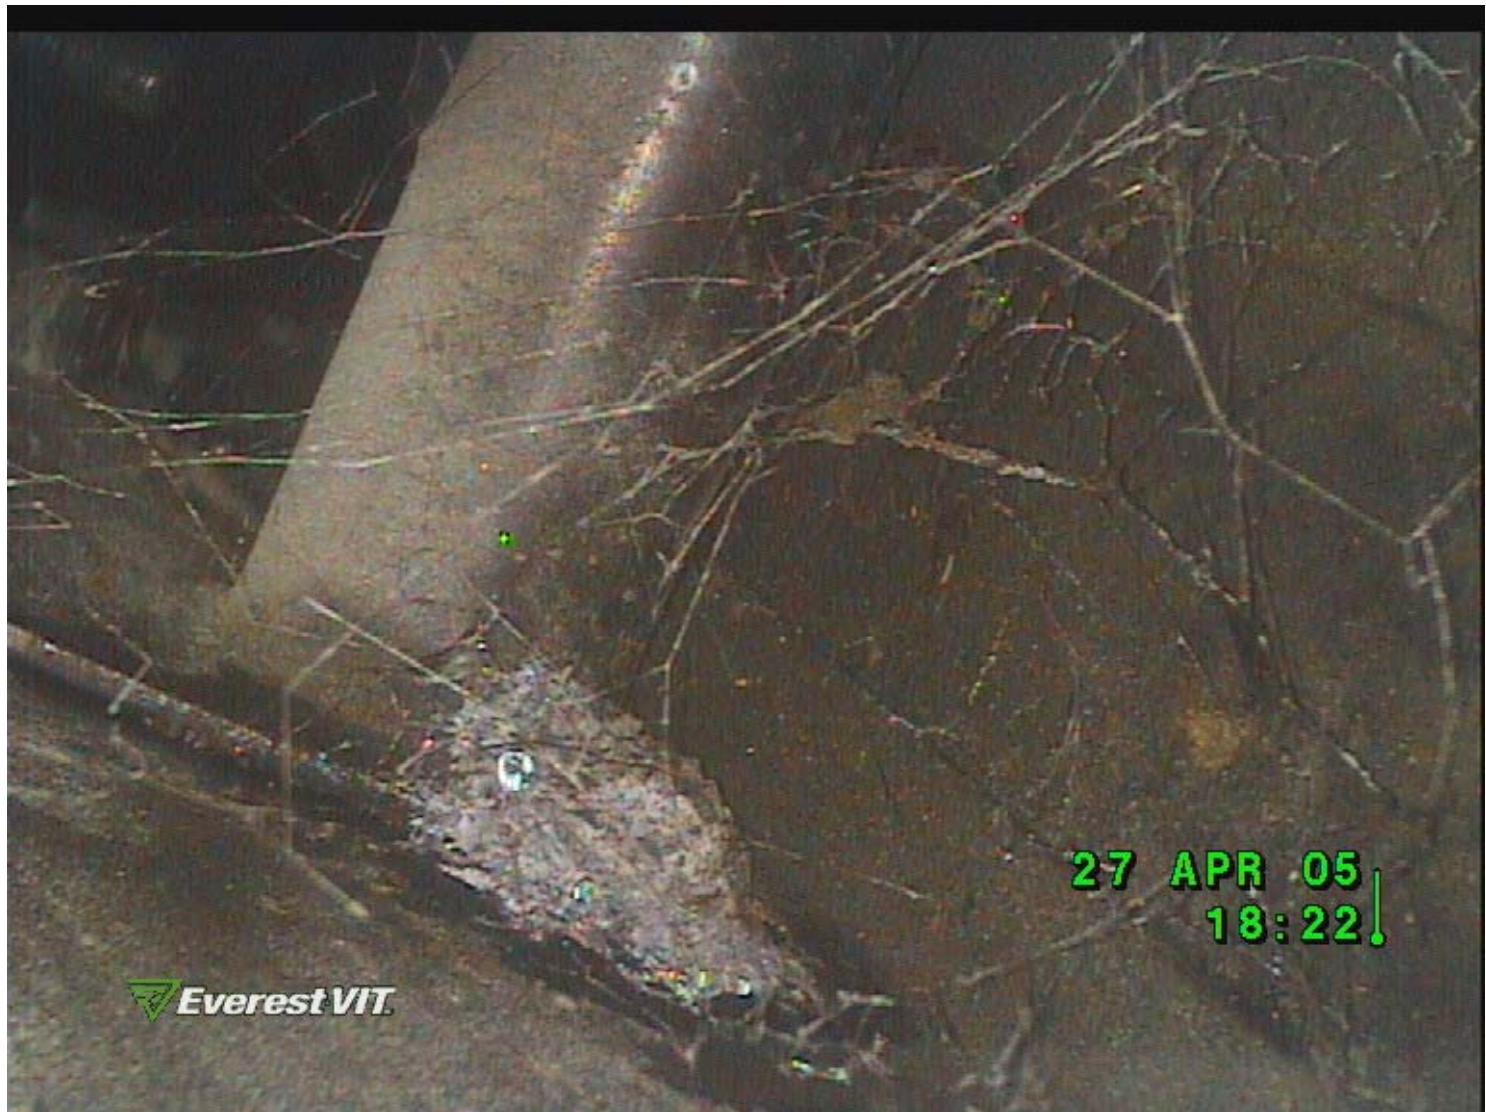
- (1) Mud/plant material construction, possible pupal case?
- (2) Plant material
- (3) Spider, could not be caught
- (4) Spider egg sac attached to metal surface in chassis member
- (5) Spider egg sac within a silk covering
- (6) Spider within chassis member.
