Biosecurity Monitoring Group

Pilot Videoscopic Survey of Imported Used Vehicles and Machinery

April – June 2005

BMG 05-06/01

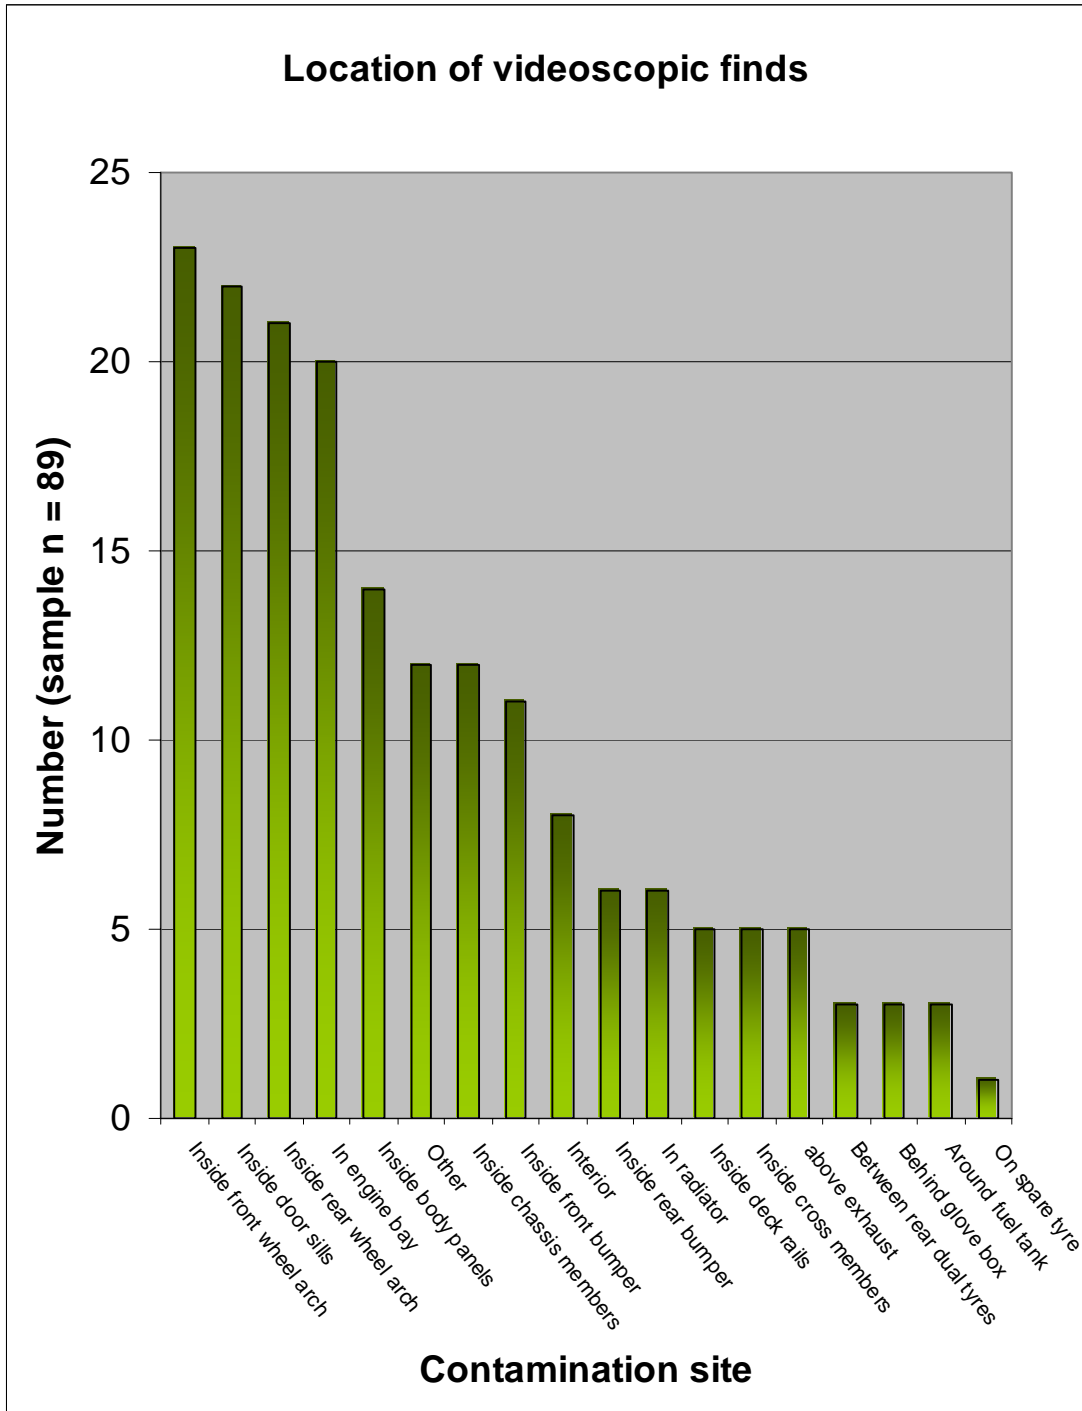
Figure 7.1 shows the locations of all instances of contamination found in the study. A high incidence occurred within hollow structural members, such as door sills, major chassis members, cross members, and inside closed body panels. A similarly high occurrence was seen in exposed areas where contaminants could accumulate, such as under mudguards and in the engine bay, but only minor contaminant numbers were found on easily cleaned sites such as tyres, fuel tanks, wheels and bumpers.

Figure 7.1. Locations within vehicles and machinery and incidences of contamination found in vehicles and machinery using videoscopic inspection

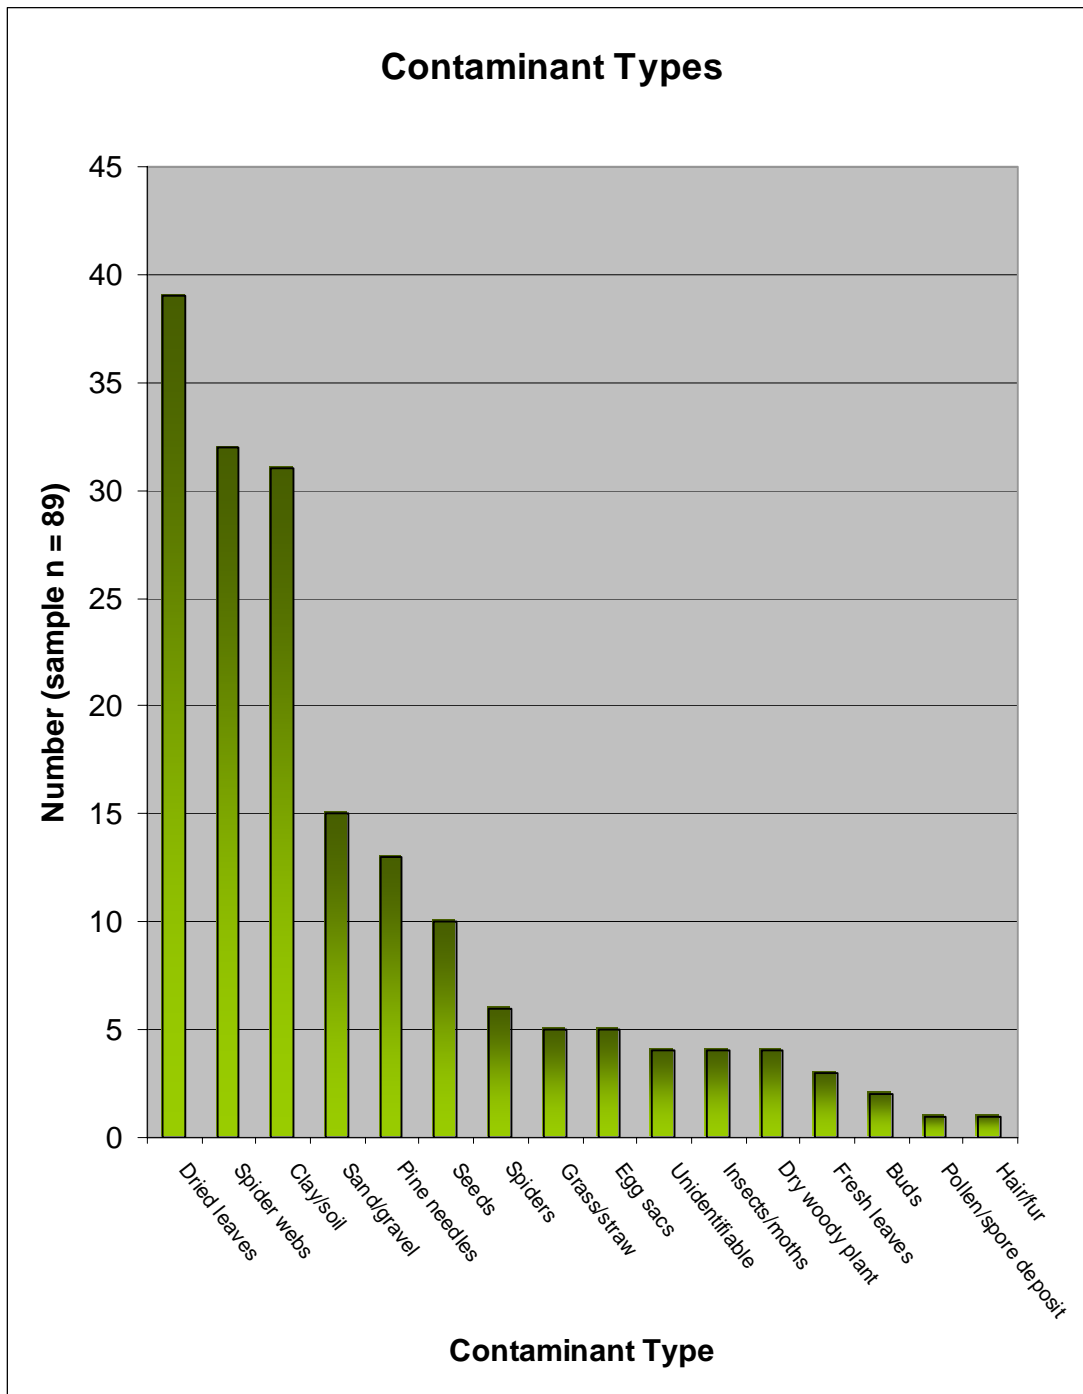
Figure 7.2 shows the types of contaminants found by videoscope inspection. Dried leaves, spider webs and clay/soil deposits were the most frequently seen contaminant types, followed by less frequent occurrences of sand and gravel. Pine needles, seeds (mainly of various grasses), dry grass/straw, small amounts of woody plant material, plant buds that appeared to have been cut off and trapped by a moving vehicle, and an unidentifiable mass of what looked to be pollen or spores made up the bulk of the minor plant components. Three occurrences of fresh leaves were seen. Four occurrences of dead insects were seen but no live insects were seen in the study. There were 6 instances of live spiders, and 6 of spider egg sacs. The abundance of spider webs suggested that other spiders could have been missed because of their secretive nature and avoidance of the video probe.

Figure 7.2. Number of instances of contaminants found in vehicles and machinery

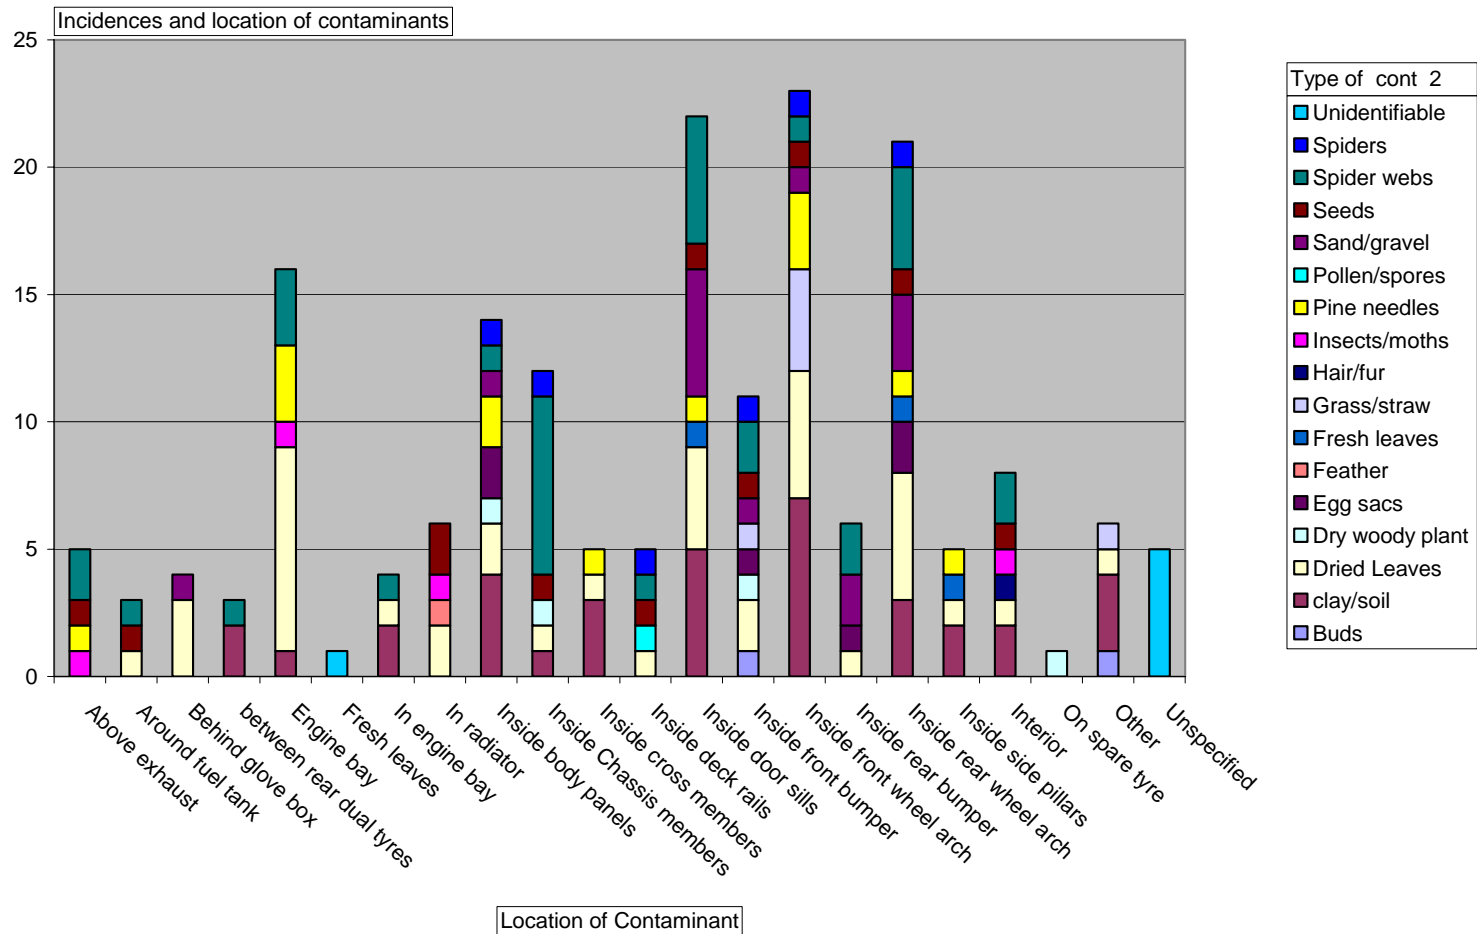
Figure 7.3 links the sites of occurrences, the types of contaminants found and the individual abundance of each contaminants at the sites in an, admittedly, complex chart. Because this chart is overly complex to interpret in anything other than a multi-colour rendition the information is summarised in Figures 7.4 and 7.5 where the types of contaminant are assigned within 6 categories.

Figure 7.3. Types of contaminants found by location

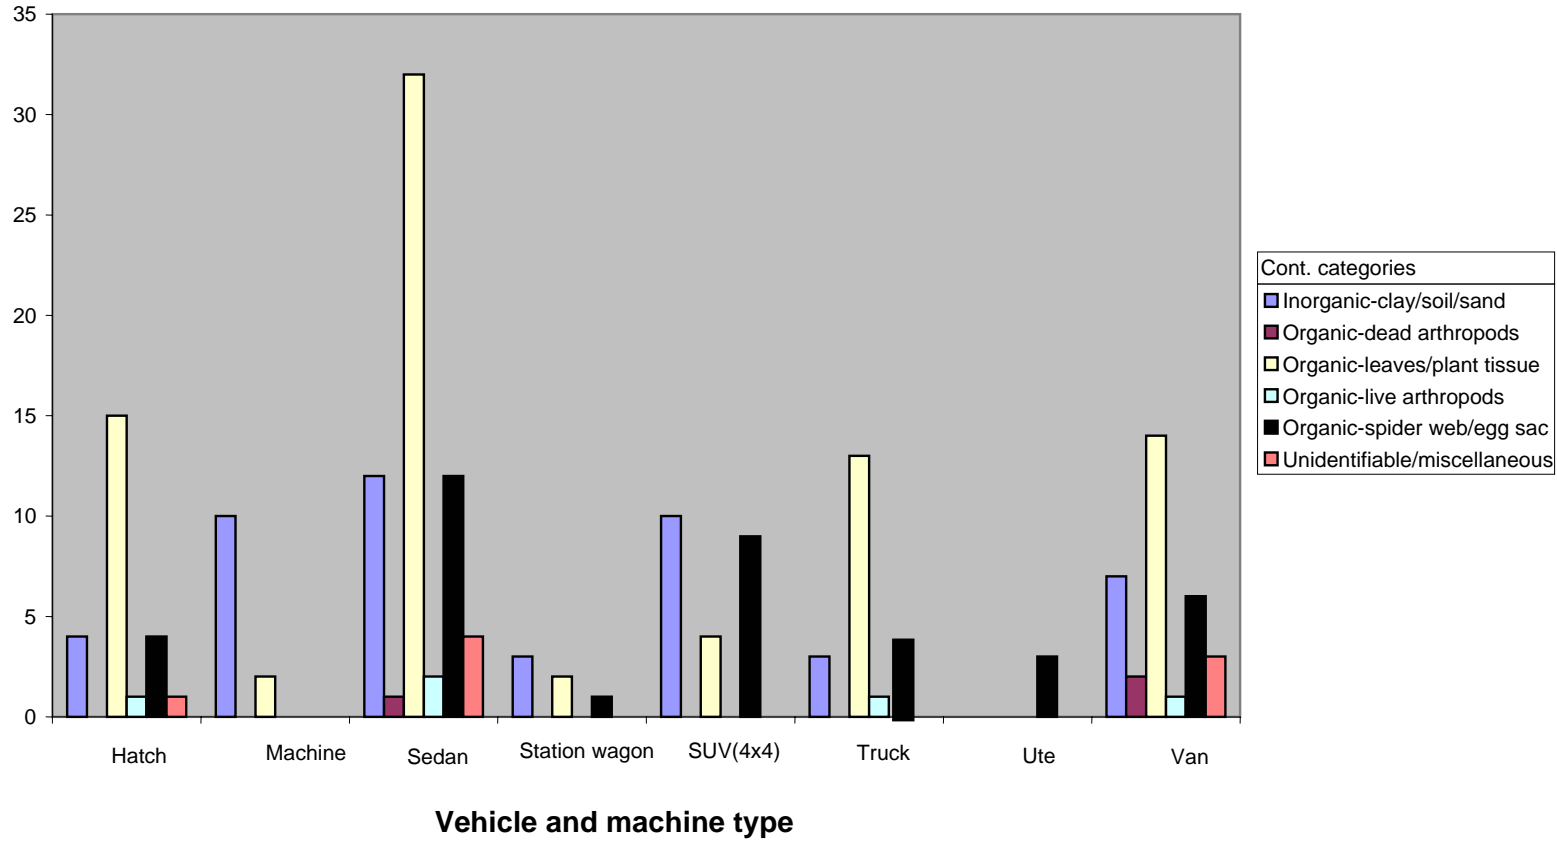
Figure 7.4. Contaminant category abundances within vehicle and machinery groups

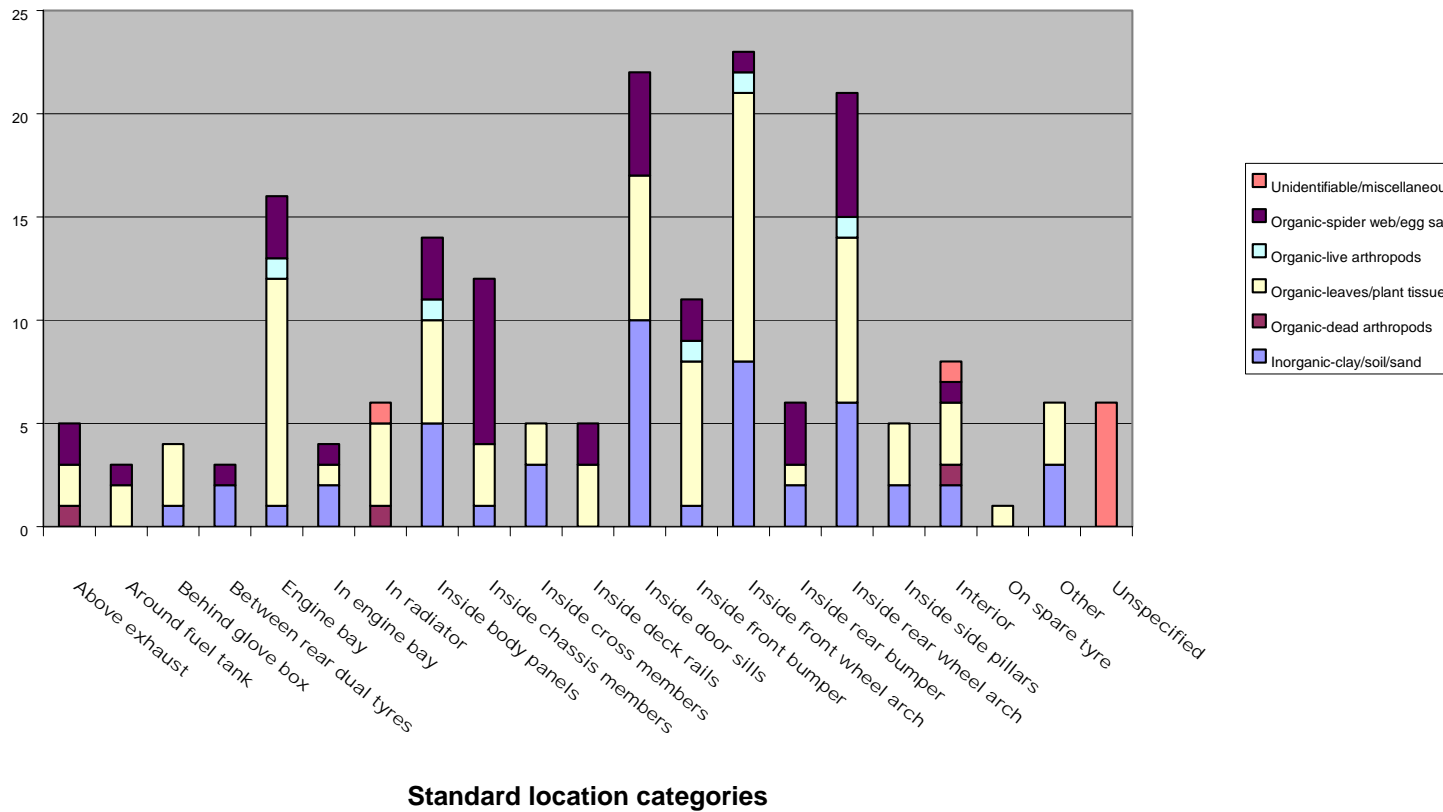
Figure 7.5. Categories of contaminants found at standard locations with videoscopic inspection
