Biosecurity Monitoring Group

Used Vehicles
Monitoring Survey
September – November 2005
BMG/05-06/10

Authors: Sarah Wedde, Chris Waite, Neil Hyde, Carolyn Whyte

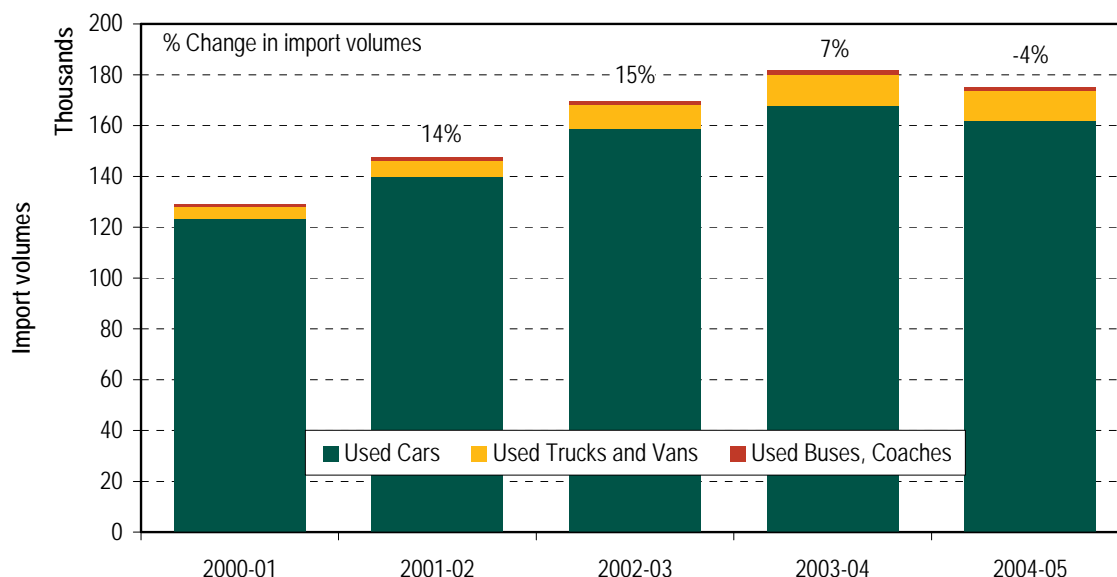
The quantity of used vehicles imported into New Zealand increased over recent years, but appears to have reached a plateau; in 2004-05 approximately 175,000 used vehicles were imported into New Zealand (Figure 4.1). The majority of these vehicles were imported from Japan (95%), while smaller proportions came from Singapore (2.6%), USA (0.9%), Australia (0.7%).

Figure 4.1. Import volumes of used vehicles imported into New Zealand between 2000-01 and 2004-05¹

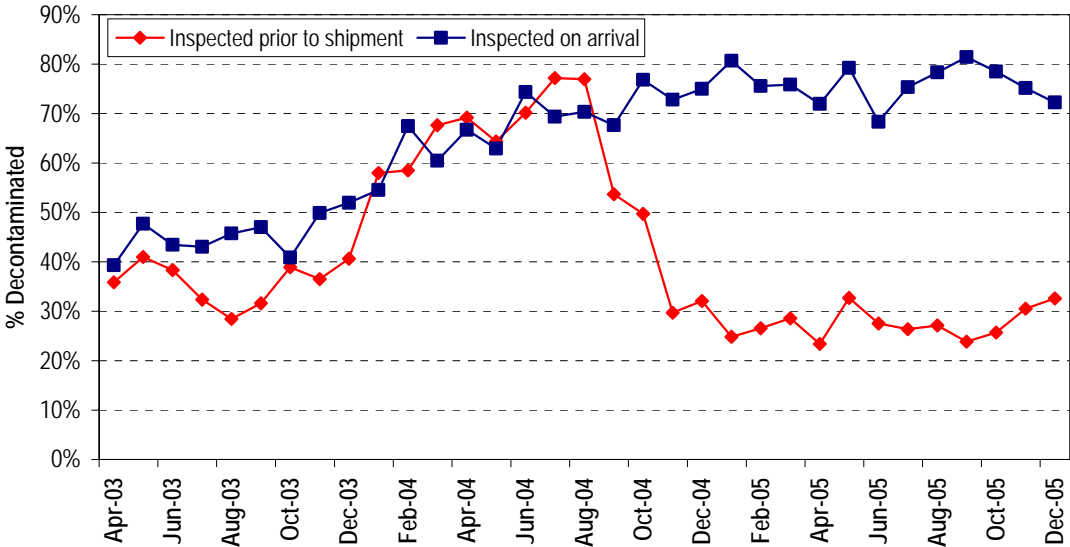
After these changes were implemented there was a substantial increase in both the inspection efficacy and the proportion of vehicles sent for decontamination. Changes in decontamination rates are shown in Figure 4.2.

Figure 4.2. The proportion of used vehicles and machinery requiring decontamination

By August 2004 approximately 75% of imported used vehicles were sent for decontamination. Since this time, the proportion of used vehicles requiring decontamination after being inspected offshore decreased substantially, to 25%. This decrease has been attributed to exporters examining and decontaminating vehicles offshore prior to presentation for MAF QS inspection. This process results in the quicker clearance of vehicles and reduces re-inspection costs. The lower proportion of used vehicles requiring decontamination offshore may also be a result of offshore MAF Quarantine Officers having the discretion to remove small amounts of contaminants at the time of the initial inspection, without requiring additional decontamination. The proportion of vehicles sent for decontamination after inspection onshore in New Zealand has remained at around 70-80%, as exporters reliant on onshore inspections have not implemented any additional pre-inspection cleaning processes.

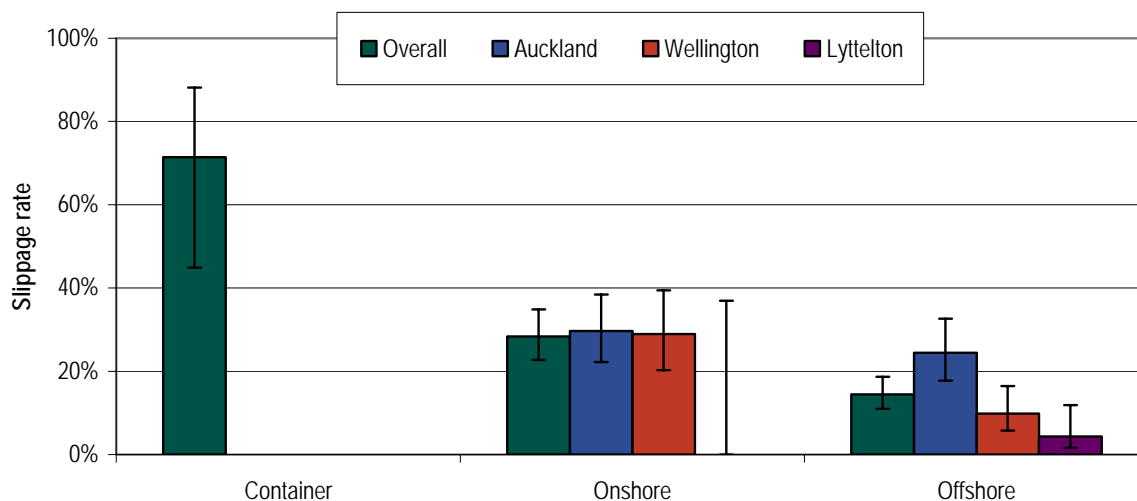
There were significant differences in slippage rates of visible contaminants between the different vehicle groups (Figure 7.1). Slippage rates were calculated as the number of contaminated vehicles in the survey sample, divided by the total number of vehicles in the survey sample. For more information on slippage rates and modelling, see Appendix I.

Containerised vehicles had the highest slippage rate, but also the greatest margin of error (due to the small sample size; only 14 containerised vehicles were surveyed). Details of the contaminants found are recorded in Appendices IV and V.

Figure 7.1. Slippage rates for visible contaminants

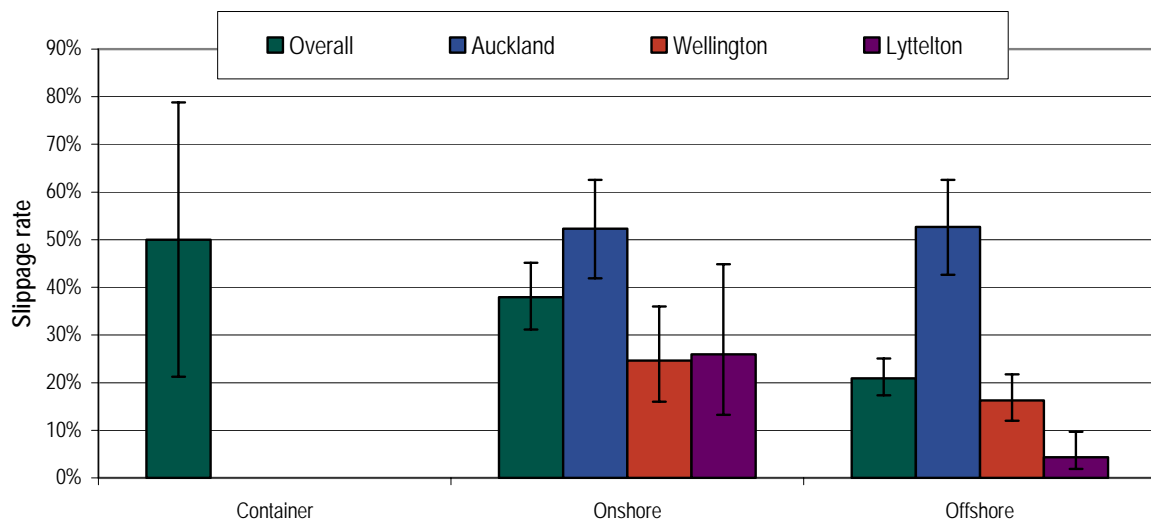
There were also significant differences in air filter contamination among vehicle groups (Figure 7.2). The slippage rate for air filter contamination was highest for containerised vehicles. The slippage rates for Auckland were higher than those for Wellington or Lyttelton.

Figure 7.2. Slippage rates for air filter contamination

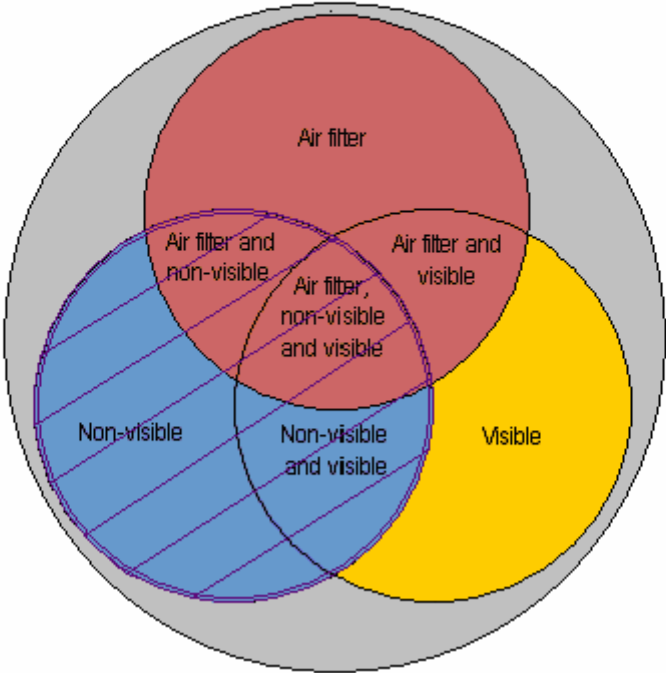
Almost all used vehicles presented for MAF inspection carry some form of contamination; it is estimated that only 6% of used vehicles are free of contamination when presented for inspection (Figure 8.1). Because 34% of vehicles are cleared on arrival in New Zealand, and only a small proportion (3%) of these have no contamination when presented for inspection, a lot of contamination currently arrives onshore.

Figure 8.1. Estimated vehicle contamination on the used vehicle pathway

- 6% No contamination
- 40% Vehicles with air filter contamination
- 48% Vehicles with non-visible contamination as estimated by the videoscope trial*
- 29% Residual vehicles with no air filter contamination, but with non-visible contamination
- 25% Residual vehicles with visual contamination only

An estimated 6,197 vehicles had contaminated air filters (40%). The current standard does not require the inspection of vehicle components that need tools for disassembly. This has been taken to include air filters as some filters are not easily removed without tools. The videoscope trial estimated that 48% of used vehicles (excluding machinery) carry contamination only visible with the videoscope. The survey estimated that 40% of vehicles have contaminated air filters. Because the two surveys were carried out independently, the proportion of vehicles with both contaminated air filters and non visible contamination was estimated as 40% x 48%, or 19%. Therefore, 29% of vehicles arriving were estimated to have non visible contamination, but no air filter contamination. Figure 8.1 shows the sources of slippage on the pathway.

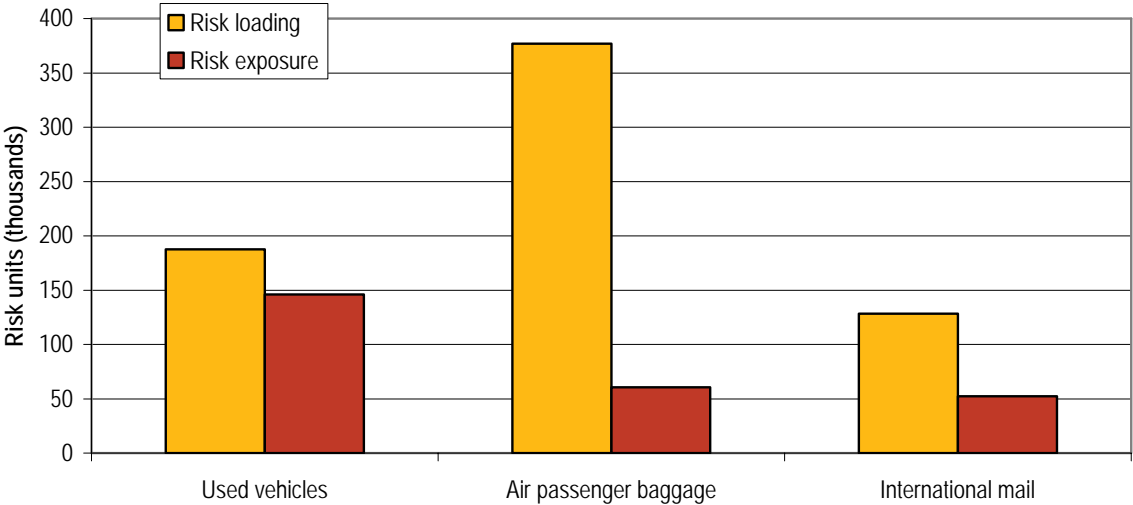
Risk loading is the total risk arriving at the border⁶, including risk mitigated by current biosecurity processes, expressed in risk units. For an explanation of risk units, see Appendix VII. The risk loading on the used vehicle pathway was estimated at 187,567 risk units in November 2005. This is less than the risk loading from air passenger pathway (Wedde *et al.*, 2005; Song *et al.*, 2005; Chirnside *et al.*, 2005b), but greater than risk loading in international mail pathway (Chirnside *et al.*, 2005a) (Figure 12.1).

Risk exposure is the measure of how much residual biosecurity risk is entering New Zealand after all biosecurity processes have been completed, and is expressed in risk units. The risk exposure on the used vehicle pathway is estimated at 145,883 risk units (Figure 12.1). This is 2.4 times the monthly risk exposure from the air passenger pathway (60,692 risk units), and 2.8 times the monthly risk exposure from the international mail pathway (52,286 risk units). The risk exposure from the used vehicles pathway is the highest measured in any survey undertaken by the Biosecurity Monitoring Group.

Figure 12.1. Comparison of risk loading and risk exposure among pathways
